Summary of the events reported in Japanese NPPs as a result of the earthquake of Friday 11th March – status on Friday 25th at 16:00 CET

Fukushima Daiichi NPP

Status of Fukushima Daiichi units as of Thursday 25th March 16:00 local time (JAIF):

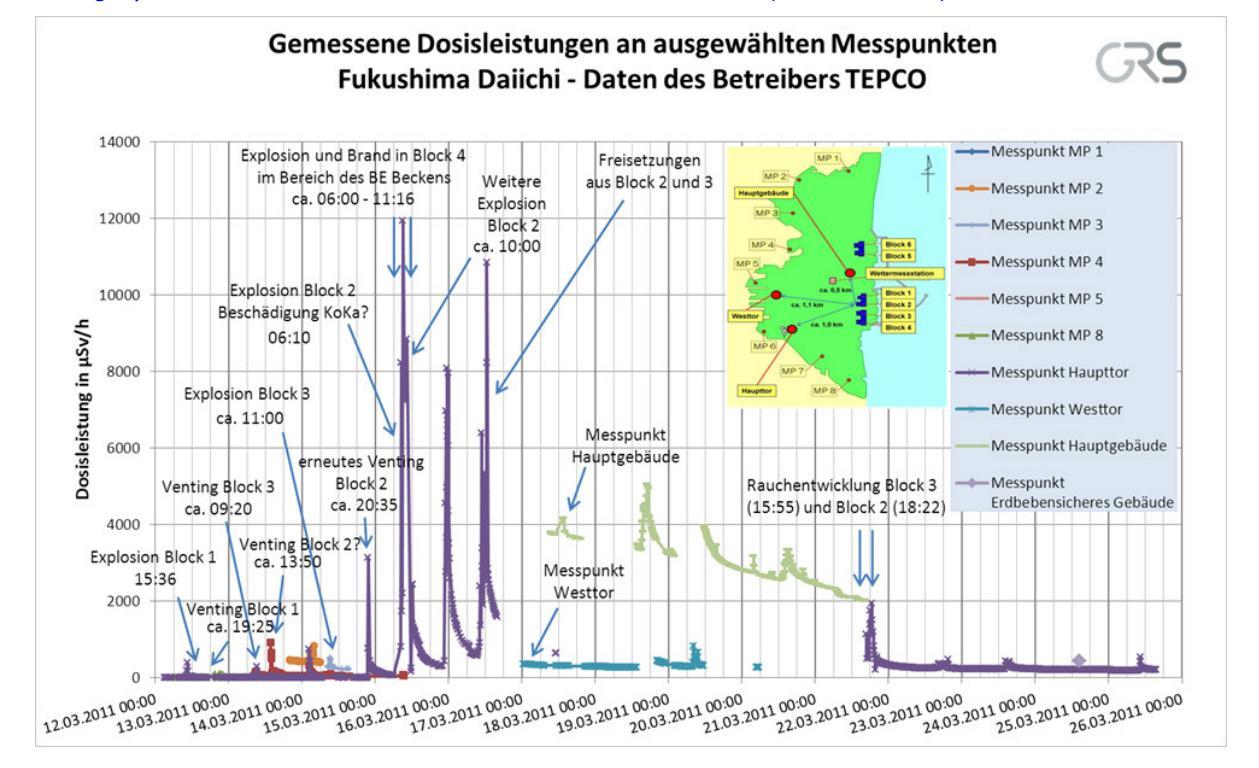
The graph hereunder shows the dose rates till March 25th (source: GRS).
