Information on Status of Nuclear Power Plants in Fukushima

Japan Atomic Industrial Forum, Inc.

Status of nuclear power plants in Fukushima as of 16:00, April 6th (Estimated by JAIF)

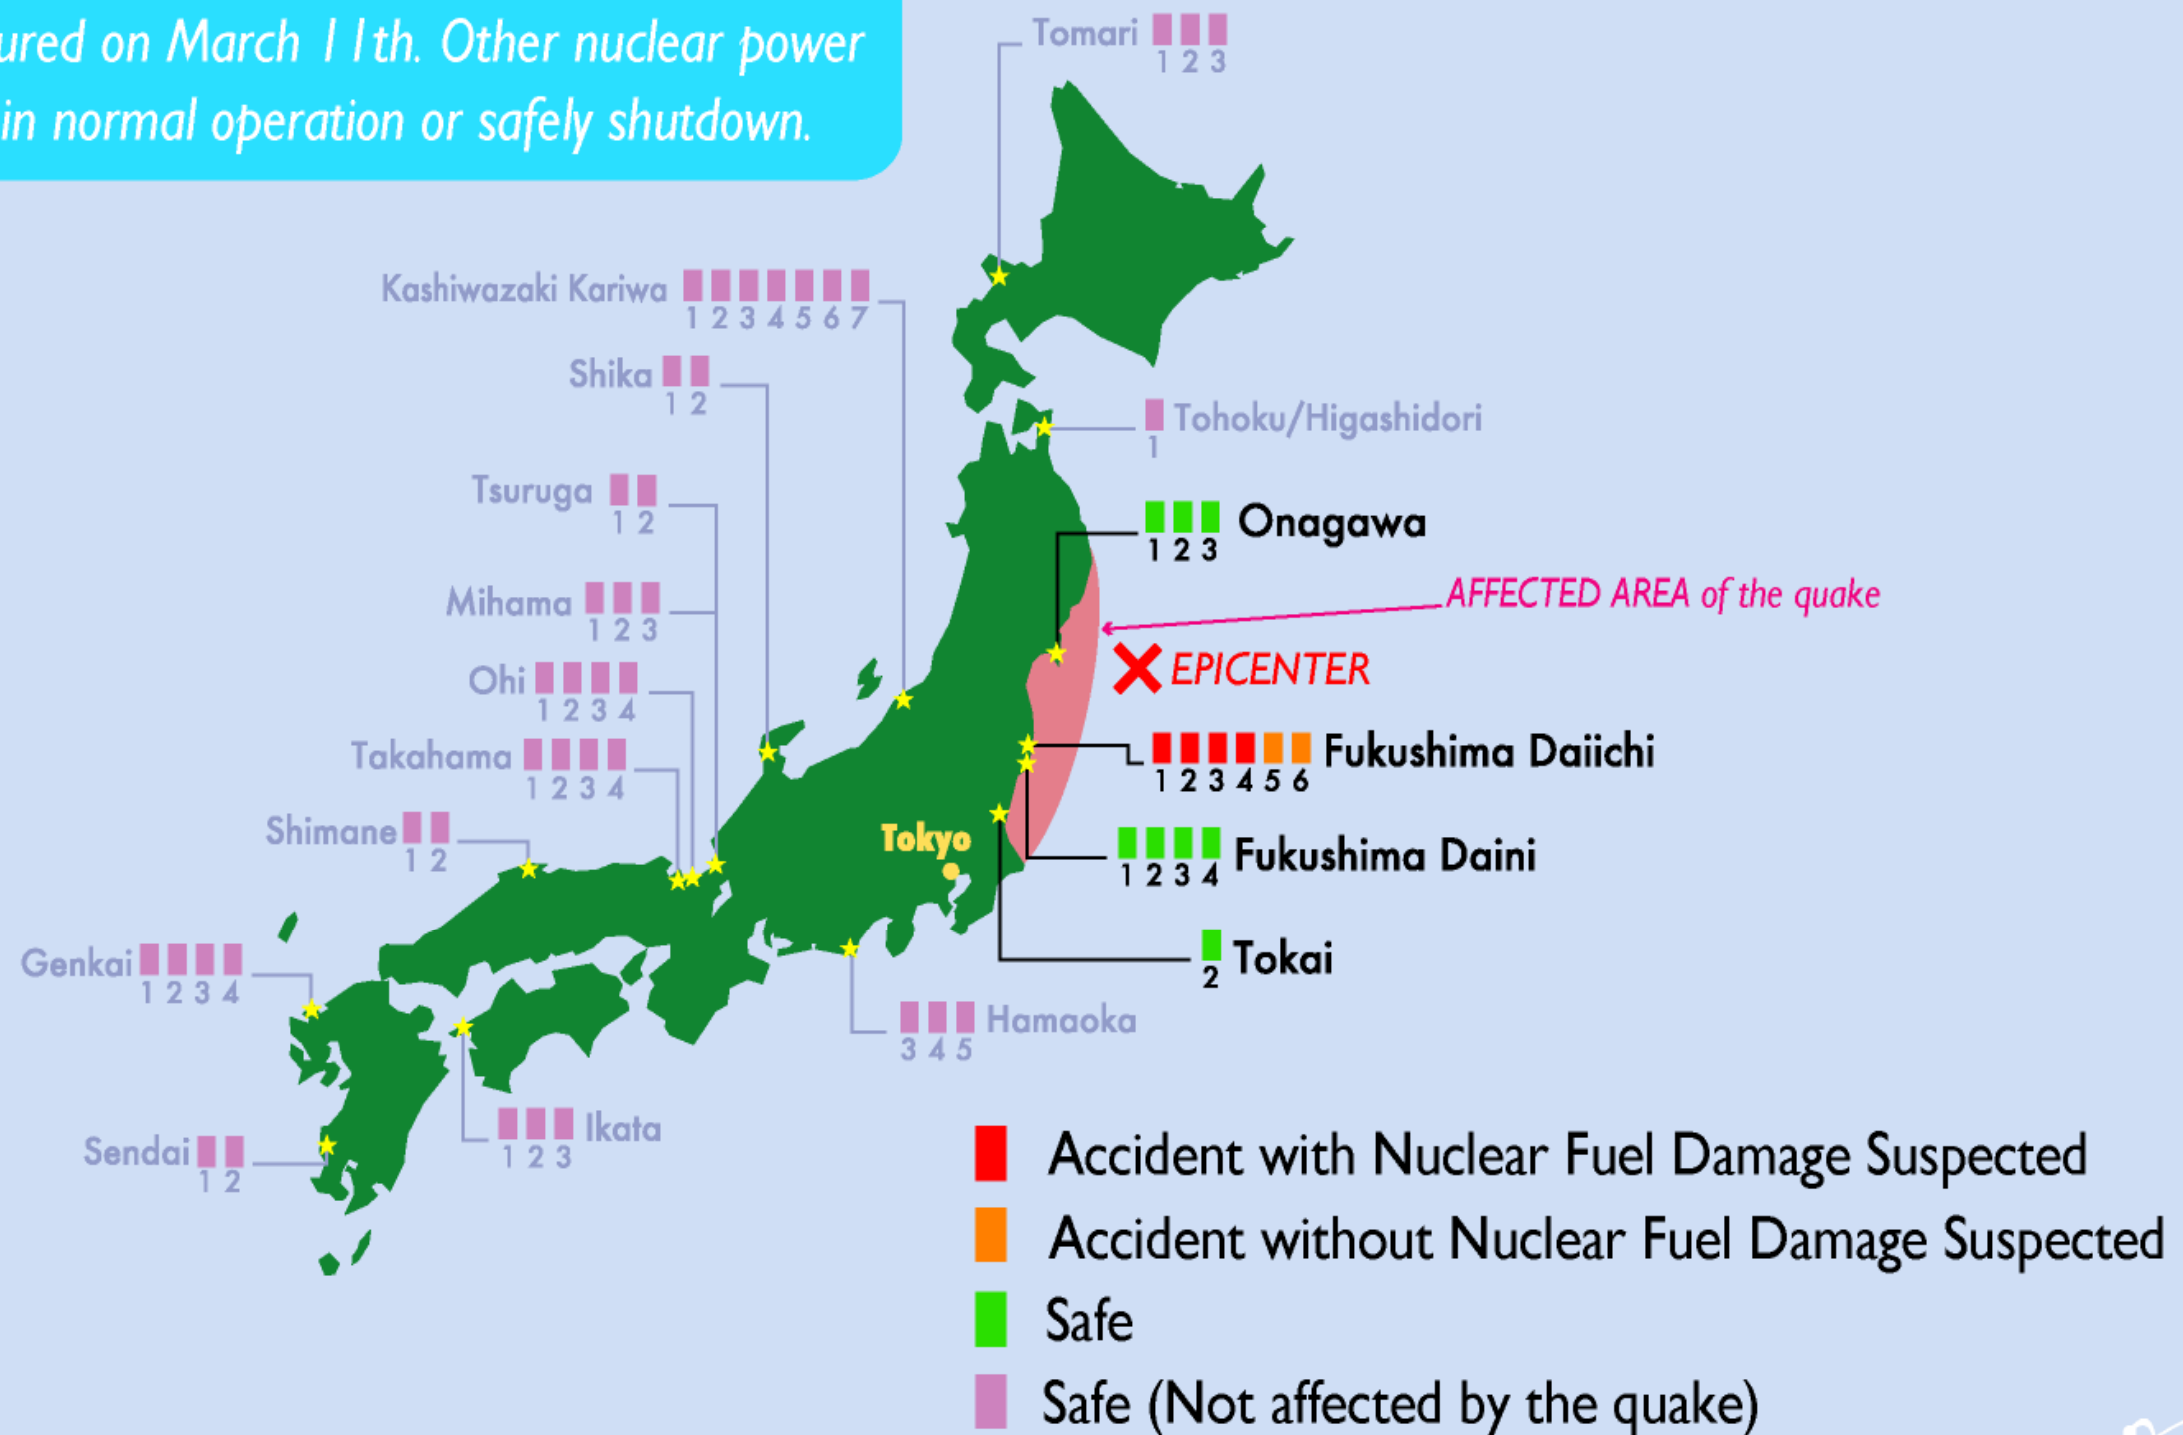
Status of the Nuclear Power Plants after the Earthquake

The accident that brings environmental impact is going on at several units in Fukushima Daiichi nuclear power Station after the earthquake occurred on March 11th. Other nuclear power plants in Japan are in normal operation or safely shutdown.
