# Information on Status of Nuclear Power Plants in Fukushima

Japan Atomic Industrial Forum, Inc.

**Status of nuclear power plants in Fukushima as of 16:00, April 18th (Estimated by JAIF)**

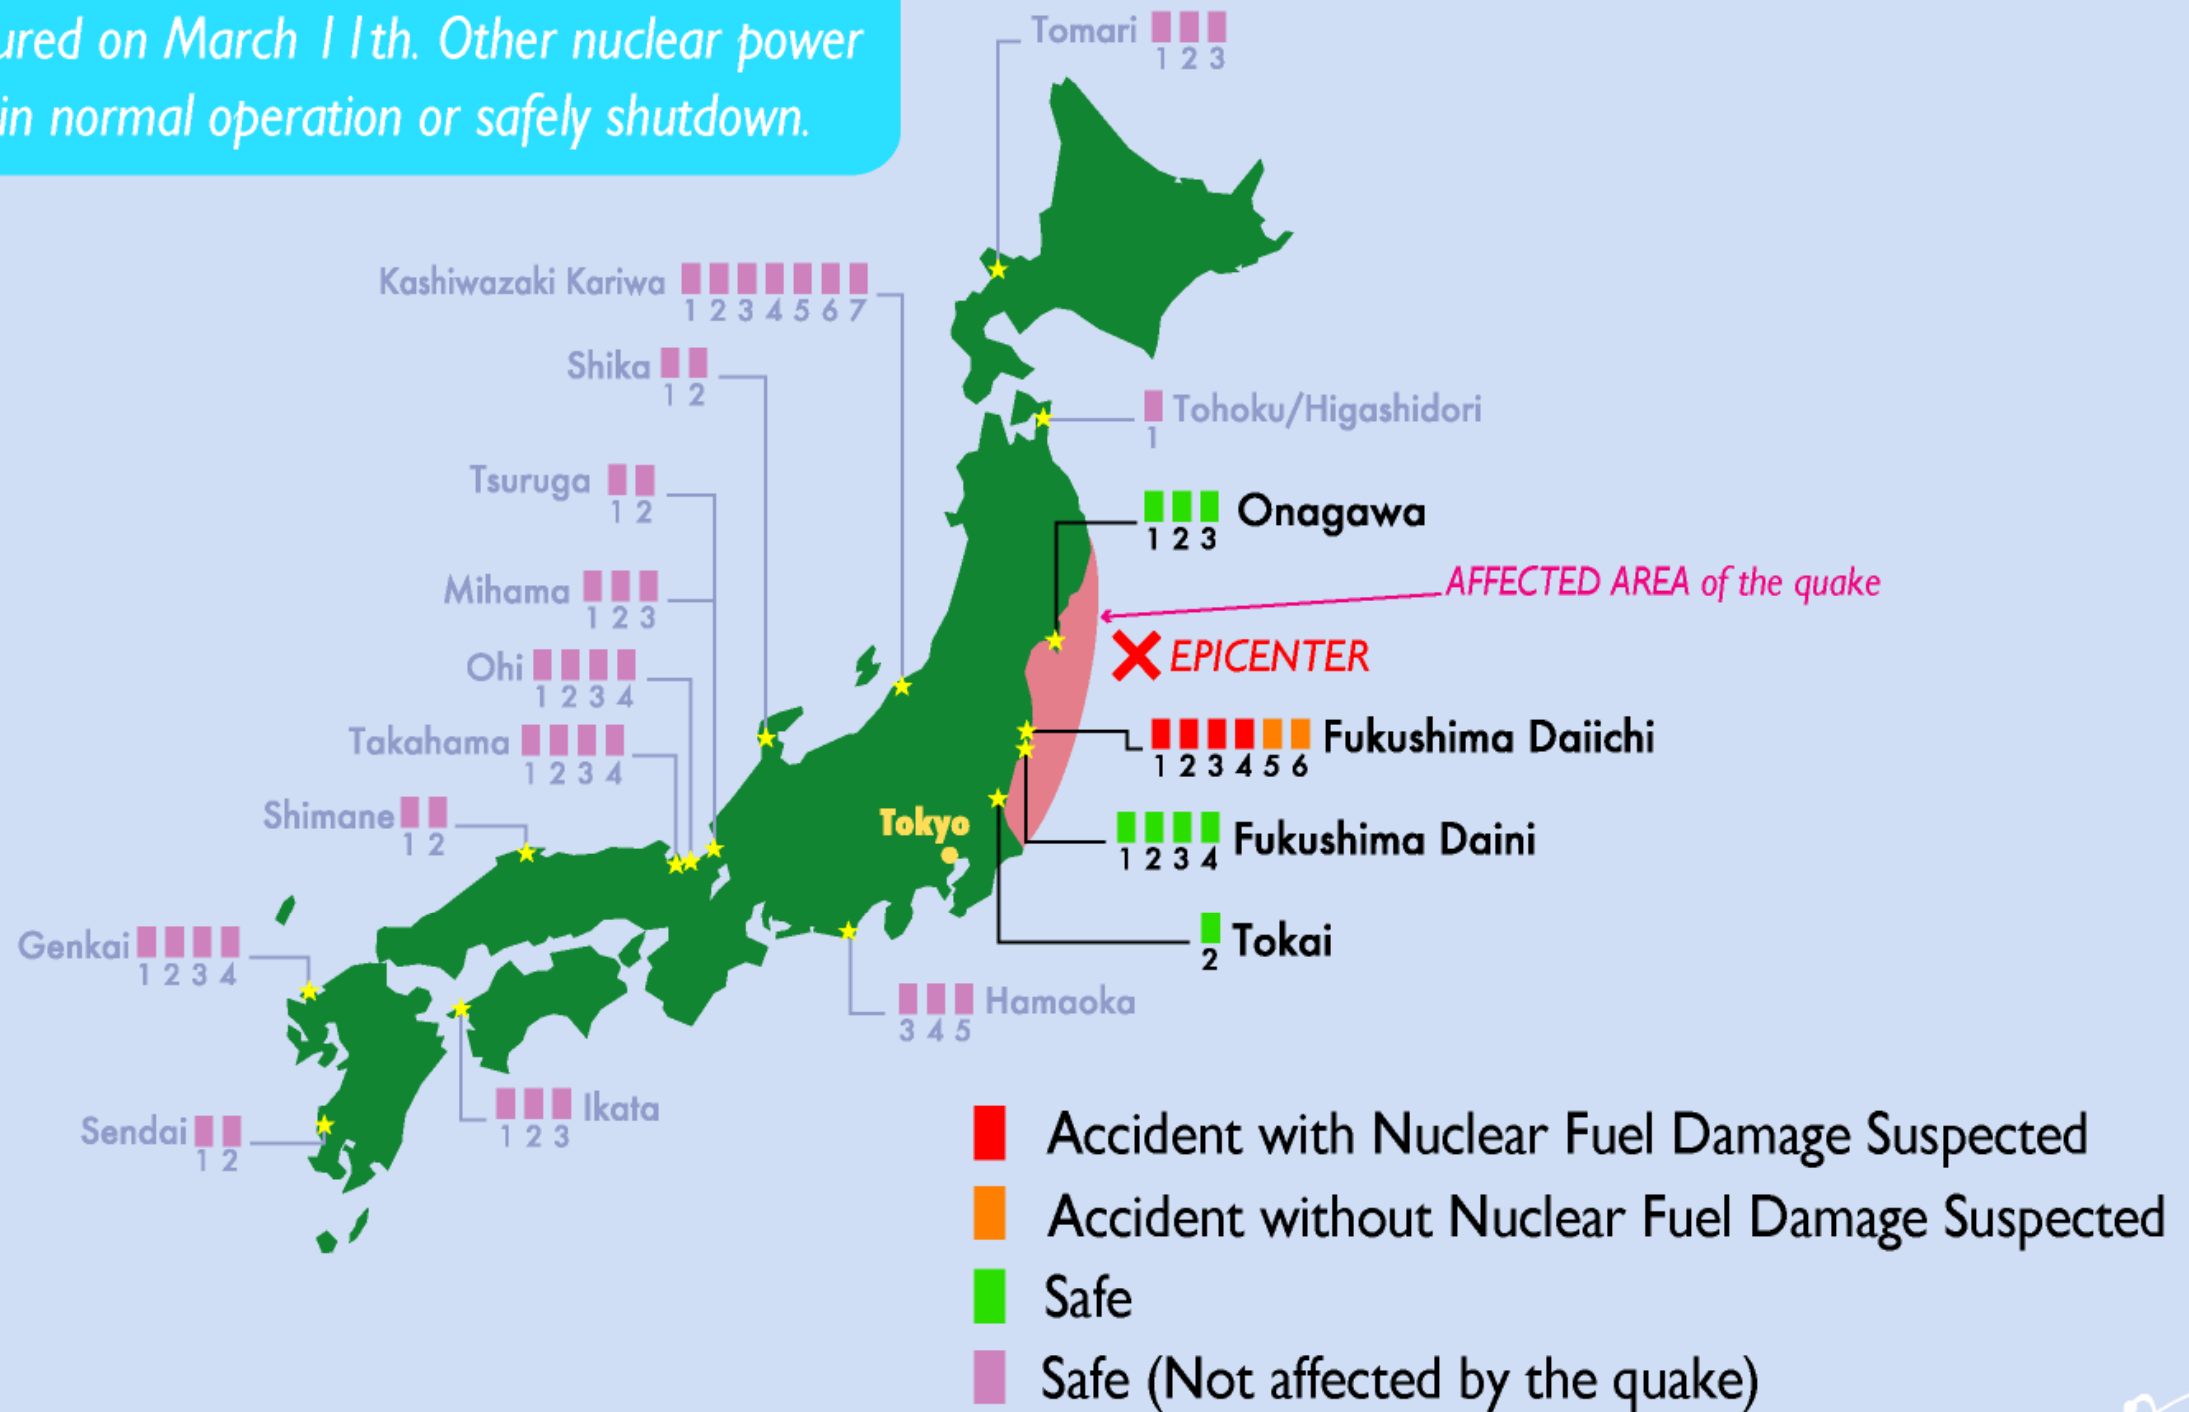
# Status of the Nuclear Power Plants after the Earthquake

The accident that brings environmental impact is going on at several units in Fukushima Daiichi nuclear power Station after the earthquake occurred on March 11th. Other nuclear power plants in Japan are in normal operation or safely shutdown.
